***DRAFT***  
**FOCUSED REMEDIAL INVESTIGATION REPORT**  
**FOR**  
**RICHARDSON FLAT TAILINGS SITE**

**SITE ID: UT980952840**

**December 17, 2002**

**Resource & Environmental Management Consultants d.b.a. RMC  
8138 South State Street, Suite 2A  
Midvale, Utah 84047**

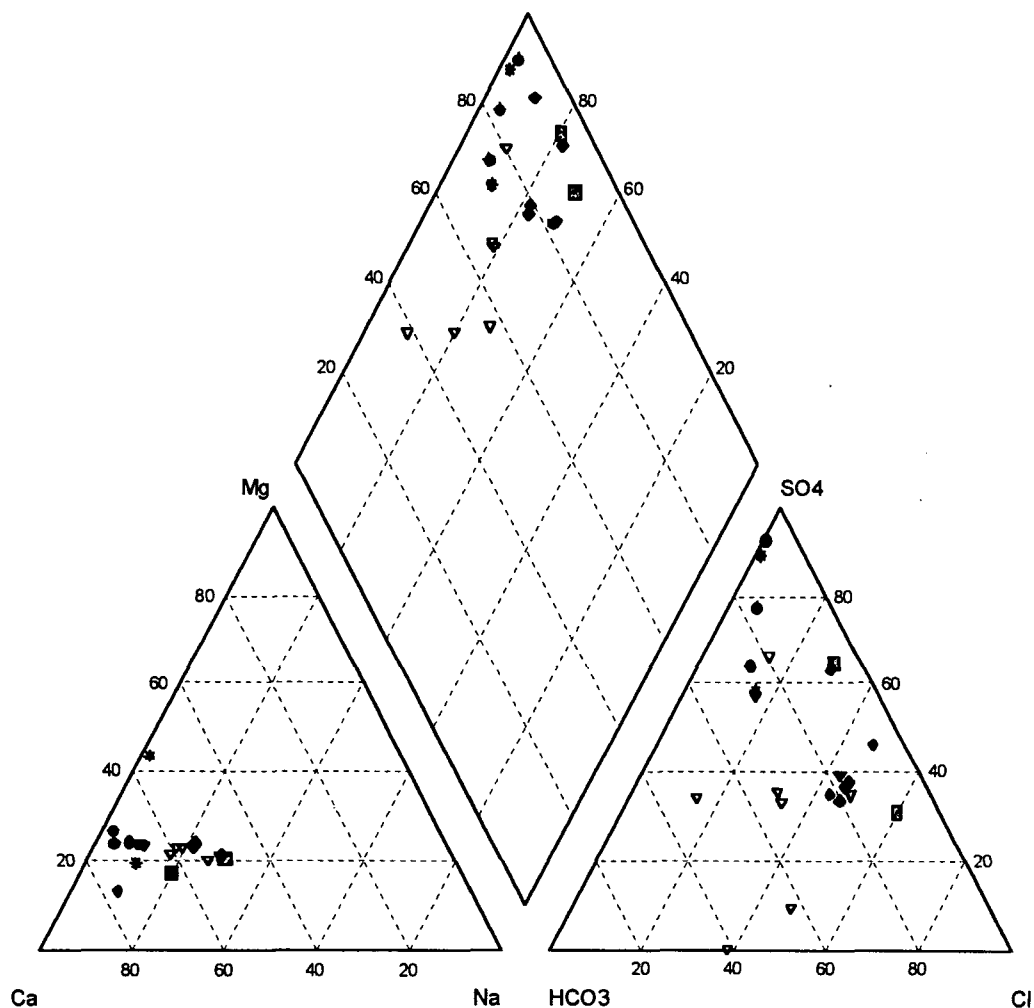
**Figure 5-13**  
**Piper Plot of May 2002 Data**

3. As shown in the Piper Plot for water samples collected during May 2002 (Figure 5-13), major ion data indicate that groundwater in the Silver Creek alluvium (RT-11, RT-12, RT-7) is similar to surface water in Silver Creek (RF-7-2 and RF-8) and the floodplain tailings indicating an intermingling of surface and ground-water along Silver Creek, while groundwater typical of the tailings impoundment area (RT-13 and RT-14) and surface water from the South Diversion Ditch (RF-6-2) generally plot as separate and distinct groups.
